SERVICE LETTER NO. 001  
September 15, 2023

**Subject:** Possible mismatching of bezel on Fuel Valve Part Number SHA200F202-120 Fuel Selector Valve LEFT/RIGHT/OFF.

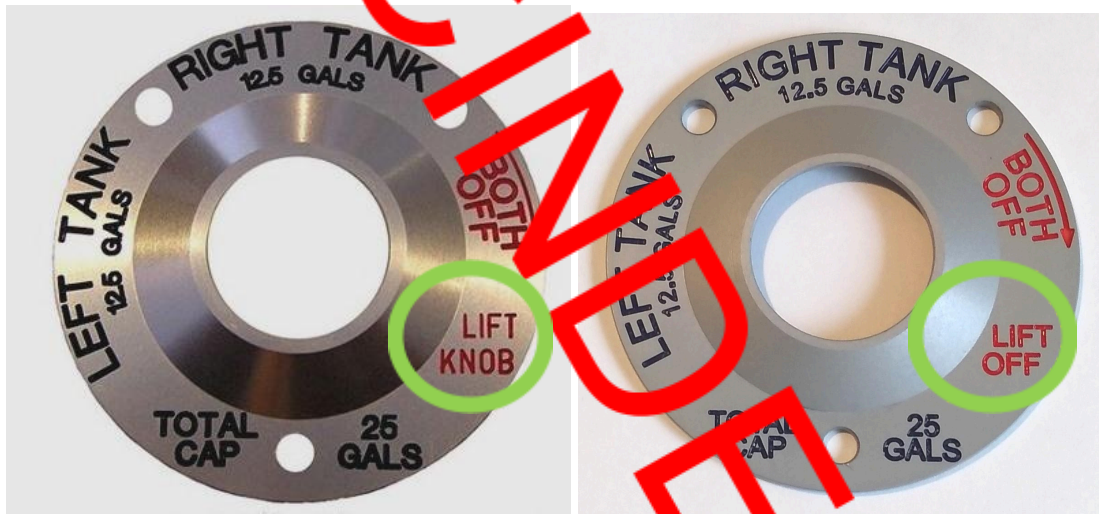
Description: The fuel bezel may have been mismatched with “LIFT OFF” instead of “LIFT KNOB” during manufacture.

Figure 1 CORRECT

Figure 2 INCORRECT

1. Sierra Hotel Aero, Inc. recommends during the next pre-flight inspection that the bezel markings be inspected to determine if it shows “LIFT KNOB” as shown in Figure 1. If the bezel is marked correctly no further action is required.
2. If the bezel is marked “LIFT OFF” as shown in Figure 2, contact Sierra Hotel Aero, Inc. at [info@navion.com](mailto:info@navion.com) or 651-306-1456 for a temporary decal that can be installed until a replacement bezel is received. The temporary decal can be installed by the owner/operator as depicted in Figure 3.
3. Upon receipt of the correct bezel at the next maintenance event, have an A&P mechanic replace the bezel and make an entry in the logbook stating the correct bezel PN SHA 200F202-120-101 has been installed.

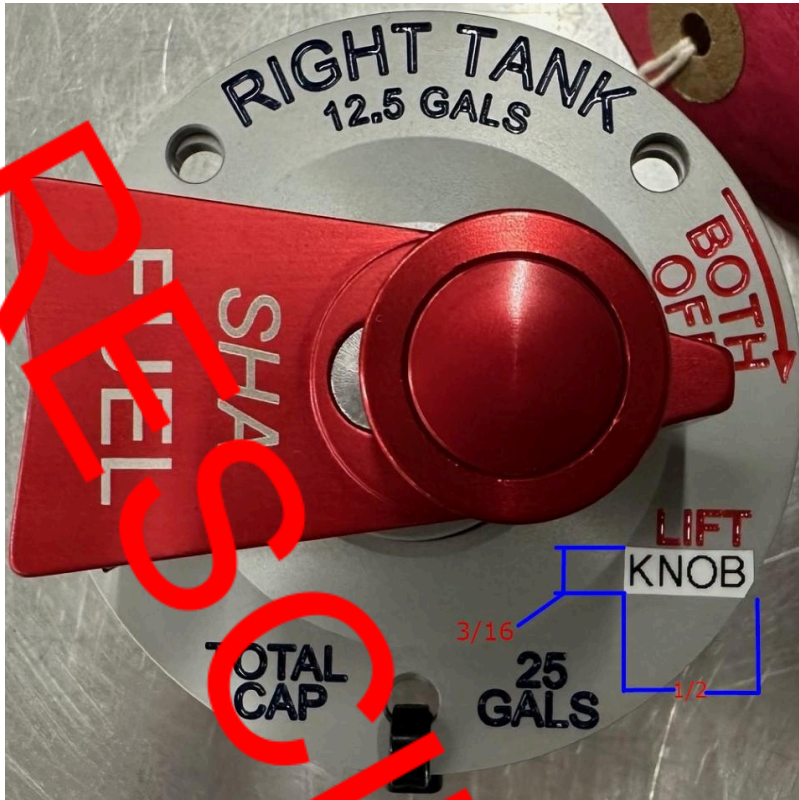
Figure 3 - Decal Installation. Dimensions as shown.
