SERVICE LETTER NO. 001
September 15, 2023

Subject: Possible mismarking of bezel on Fuel Valve Part Number SHA200F202-120 Fuel Selector Valve LEFT/RIGHT/OFF.

Affected Serial Numbers: 61039, 61040, 61041, 61042

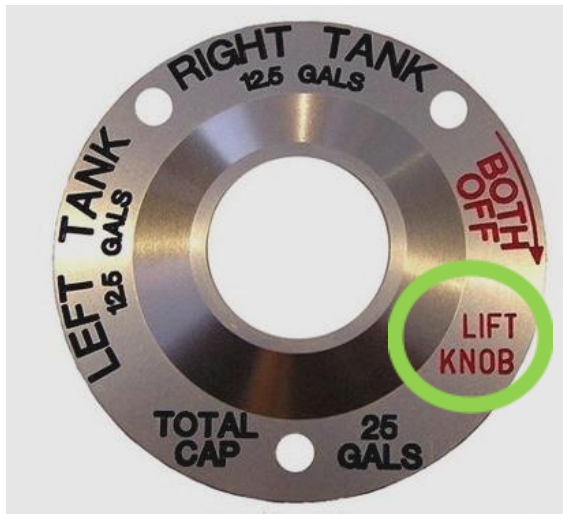
Figure 1 CORRECT

Description: The fuel bezel may have been mismarked with “LIFT OFF” instead of “LIFT KNOB” during manufacture.

1. Sierra Hotel Aero, Inc. recommends during the next pre-flight inspection that the bezel markings be inspected to determine if it shows “LIFT KNOB” as shown in Figure 1. If the bezel is marked correctly no further action is required.
2. If the bezel is marked “LIFT OFF” as shown in Figure 2, contact Sierra Hotel Aero, Inc. at info@navion.com or 651-306-1456, for a temporary decal that can be installed until a replacement bezel is received. The temporary decal can be installed by the owner/operator as depicted in Figure 3.
3. Upon receipt of the correct bezel or at the next maintenance event, have an A&P mechanic replace the bezel and make an entry in the logbook stating the correct bezel PN SHA 200F202-120-101 has been installed.

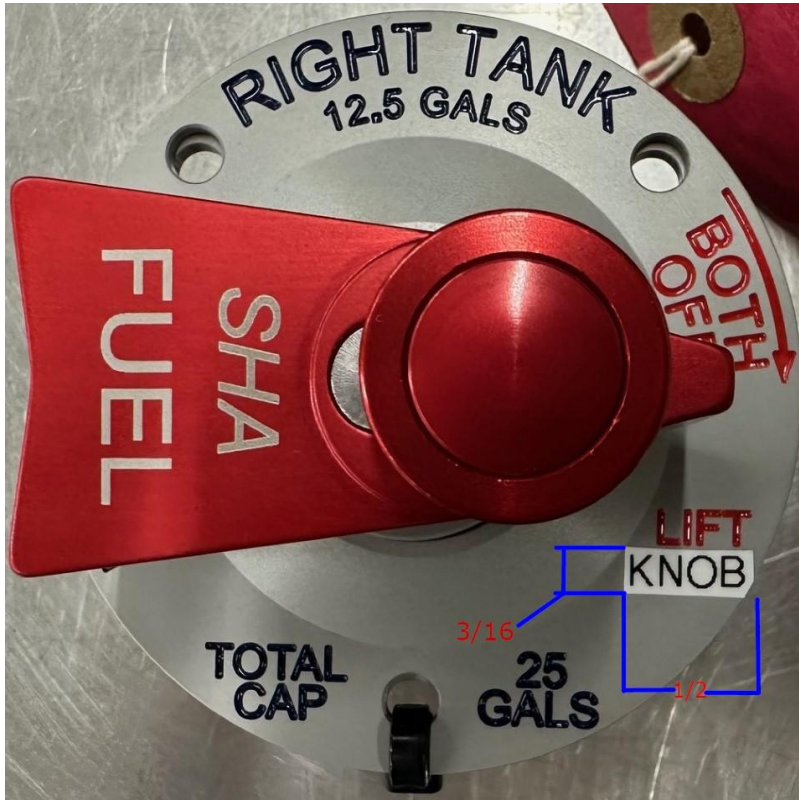
Figure 3 - Decal Installation and Dimensions as shown.
